9th October 2017

Project Number UK14-23656

CBG BAUXITE MINE EXPANSION ENVIRONMENTAL AND SOCIAL MONITORING REPORT - JULY 2017

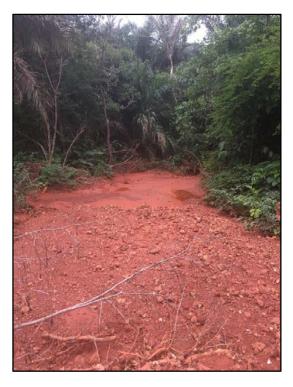
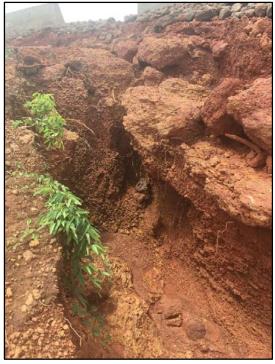
Figure 10-4: Left – large area of sedimentation and run-off from COBAD road in gallery forest critical habitat, right – two-metre deep eroded pit in COBAD road drainage ditch

During the July 2017 site visit, significant erosion and sedimentation into rivers from the COBAD road were observed. The exposed banks alongside road cuttings have not been stabilised and are already showing signs of erosion. The road side drainage ditches are unlined and significant wash out is

already taking place at the bottom of slopes. Inadequate sediment traps have been installed in some locations, but the ditches discharge largely straight into the rivers. Therefore, sediments eroded from the banks and ditches are likely to cause significant impacts to the watercourses. If COBAD are unwilling to implement mitigation and restoration, CBG should assess what measures it can take to rectify the situation.

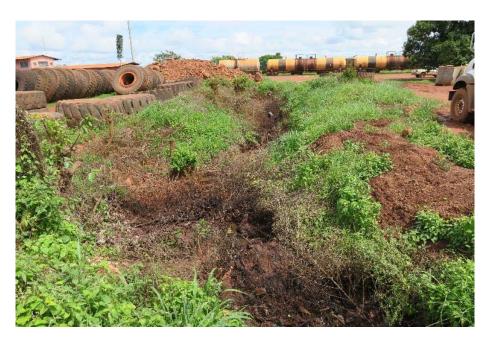
In November 2016, Ramboll Environ found evidence of oil contamination at the main site discharge location within the Sangarédi maintenance/office area. In this site visit the same area was revisited and similar levels of oil contamination were noted (Appendix 3, photos 1 and 2). The pooled oil and contamination in the drainage channel were reportedly due to a recent failure of the oil water separator. Ramboll Environ acknowledged the explanation and noted a replacement pump, but nevertheless has concerns that on both visits significant oil contamination was noted and, also, that site personnel were unaware of the oil.

Photo 1. Sangaredi maintenance workshops – oil contaminated drainage channel downstream of oil water separator

In future, it is recommended that the operation/maintenance of the oil water separator is closely monitoring. Water quality should also be routinely monitored at suitable locations such as the boundary of the site and outlet of the oil water separator. Finally, collection of pooled oil and remediation of contaminated soil is necessary.

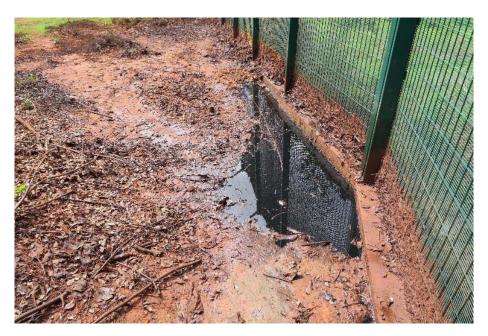
Photo 2. Sangaredi maintenance workshops – pooled oil at discharge location on the site boundary

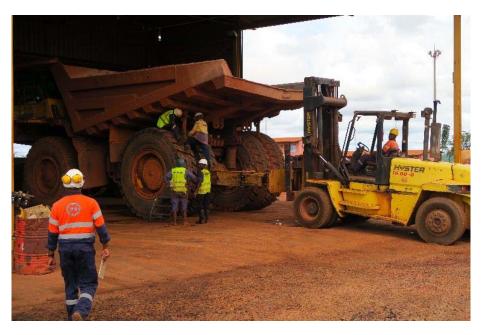
- Use of forklift forks as a working platform (Appendix 3, photo 3);
- Unprotected fall hazards (Appendix 3, photo 7);
- · An incidence of unsuitable footwear; and
- Failure to use dust masks in a dusty environment e.g. bauxite loading at the mineral quay.

Photo 3. Poor working practices – note use of forklift truck as working platform

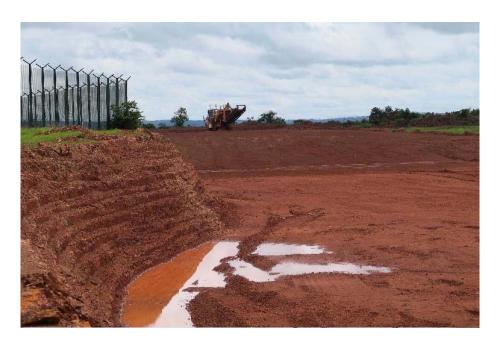
Photo 4. Surface miner – note creation of steep and unstable mine face

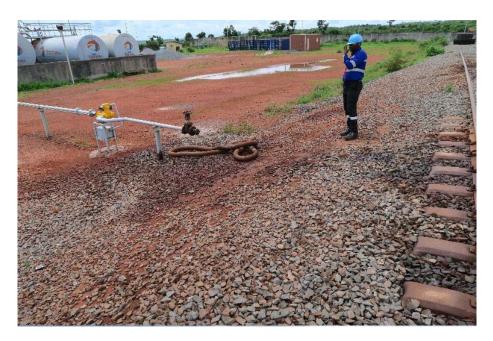
Photo 5. Fuel spillages at Sangaredi power plant – same spillages observed in November 2016

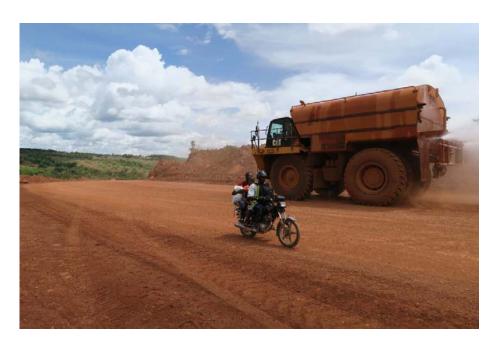
Photo 6. Unimpeded use of CBG Haul roads by villagers

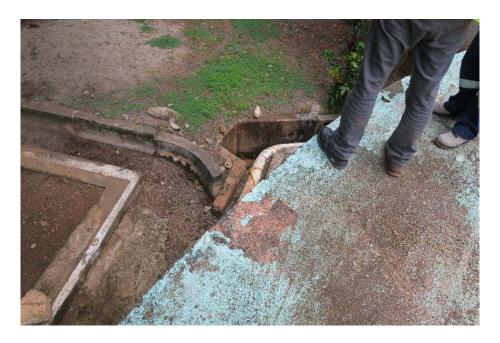
Photo 7. Unprotected raised platform at water treatment plant – fall risk

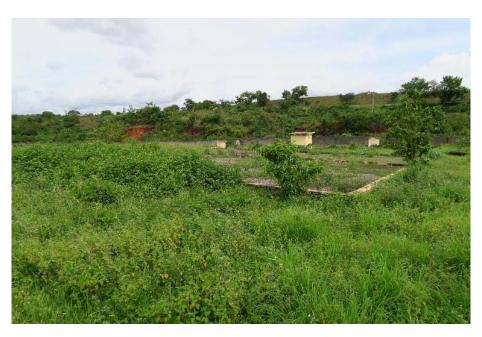
Ramboll Environ's overall impression is that the WWT plant is not managed and is highly unlikely to be working efficiently. It is therefore recommended that CBG undertakes a comprehensive review of the WWT plant including:

Photo 10. Waste water treatment plant at Sangaredi – overgrown (inefficient) filtration beds

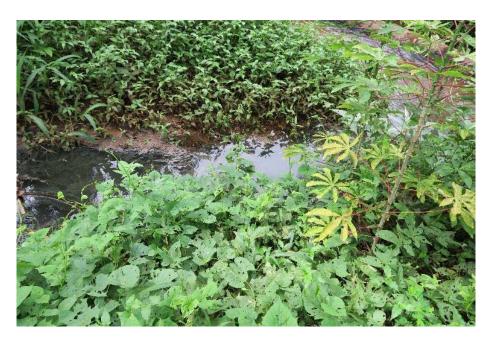
Photo 11. Discharge downstream of Sangaredi WWT plant at confluence with another stream

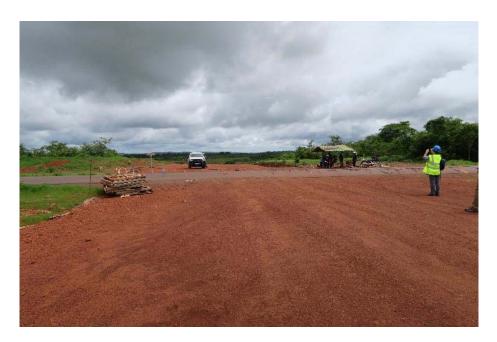
Photo 12. Crossing of COBAD Road and the main road between Boke and Sangaredi (N3) – no overpass/underpass as referenced in the ESIA

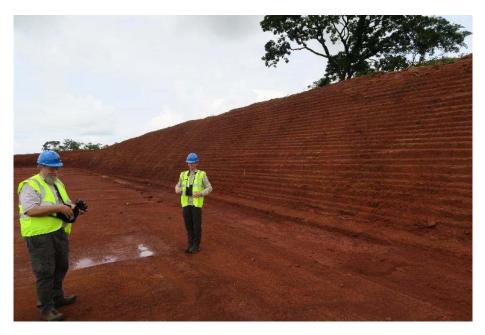
Photo 13. Section 3 of COBAD Road – transfer station. Unprotected steep slopes created by surface miner

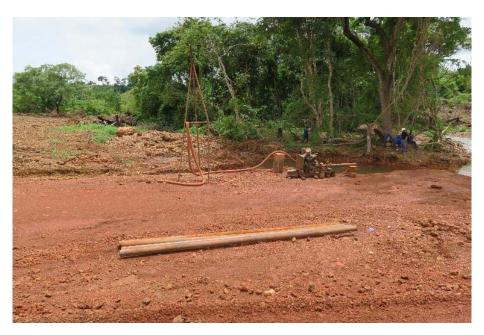
- Abstraction of surface waters (Appendix 3, Photo 14);
 - Refuelling in or close to water courses;
 - Failure to protect a vulture nest on the transfer site; and

Photo 14. COBAD Road – abstraction of surface water contrary to mitigation measures specified in the ESIA

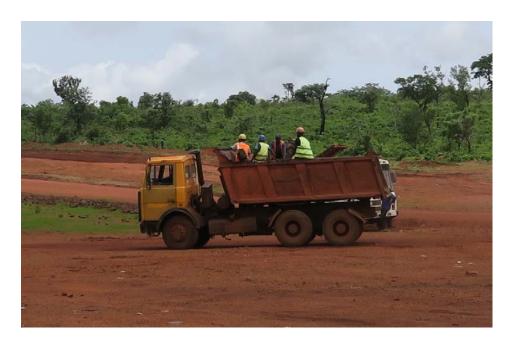
Photo 15. COBAD Road - poor H&S practices are common place

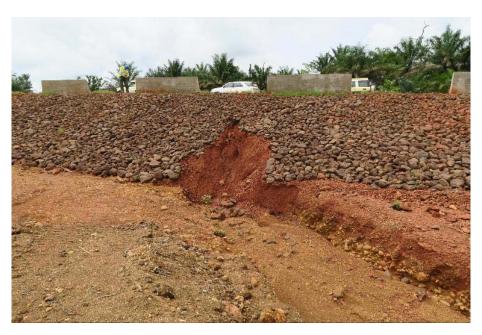
Photo 16. Recently completed section of COBAD Road – erosion and damage to rock armoured slopes

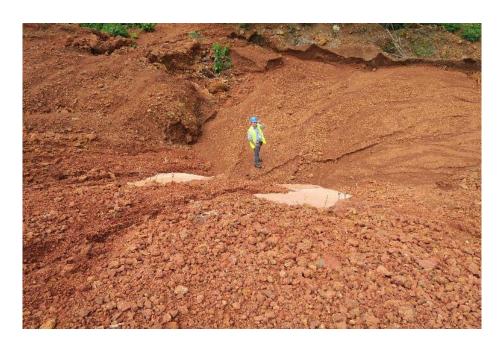
Photo 17. COBAD Road – erosion leading to siltation of watercourses

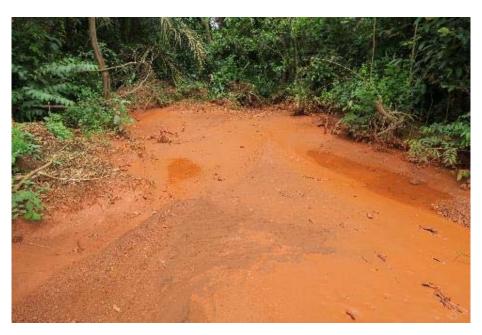
Photo 18. COBAD ROAD - discharge of fine sediments to stream located in the vegetation

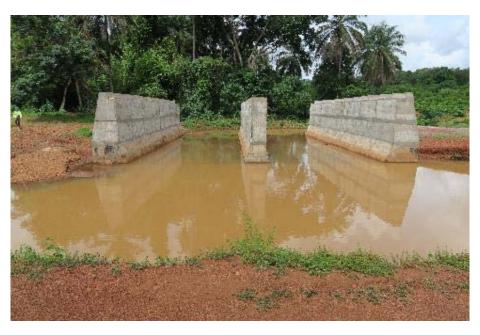
Photo 19. Part constructed bridge on the abandoned section of the COBAD Road – no progress since Nov 2016 visit

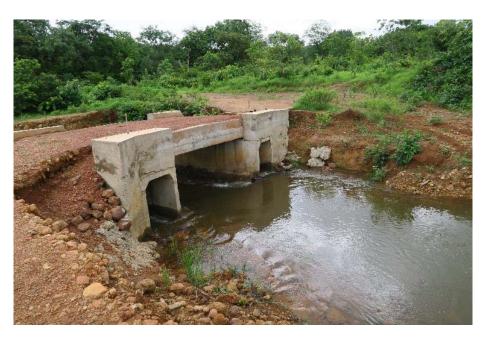
Photo 21. Significant erosion around bridge – wooden planks required to cross bridge on the far side following erosion

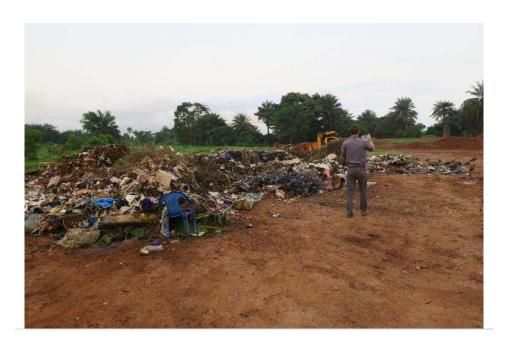
Photo 23. Tora Bora – waste will need to be move during site preparation

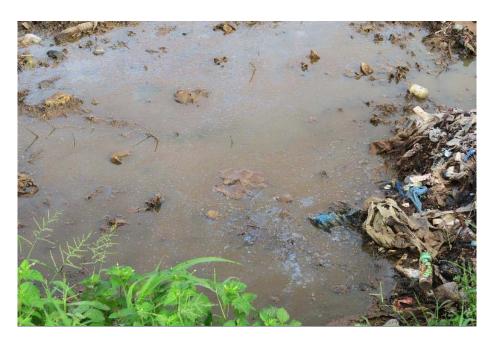
Photo 26. Kamsar landfill – large areas of standing water including traces of hydrocarbons

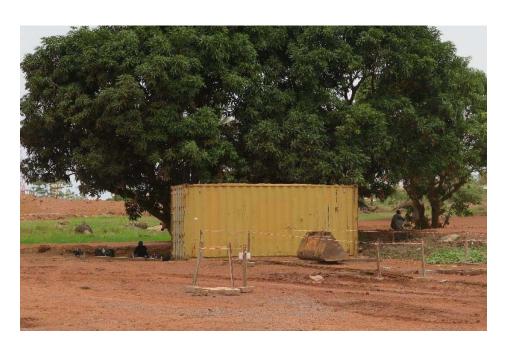
Photo 31. Unauthorised personnel – security and H&S risk

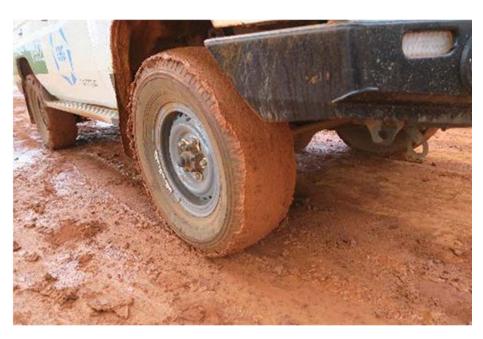
Ramboll Environ also noted the large amounts of dust on the mineral quay caused by losses from the conveyor belts and actual loading arm (Appendix 3, photo 34). At the time of the visit (early rainy season) wetted dust became very slippery for pedestrians and vehicles. Photo 33 shows the effect on tyre tread. Ramboll Environ observed skidding vehicles on the mineral quay with obvious potential for accidents.

Photo 33. Rainfall and large volumes of dust from loading made jetty very slippery for pedestrian and vehicles – skidding vehicles noted
